Monitoring Completed Navigation Projects (MCNP) Program

5-6 December 2005 (FY06)
Alexandria, Virginia

Coastal and Hydraulics Laboratory - ERDC

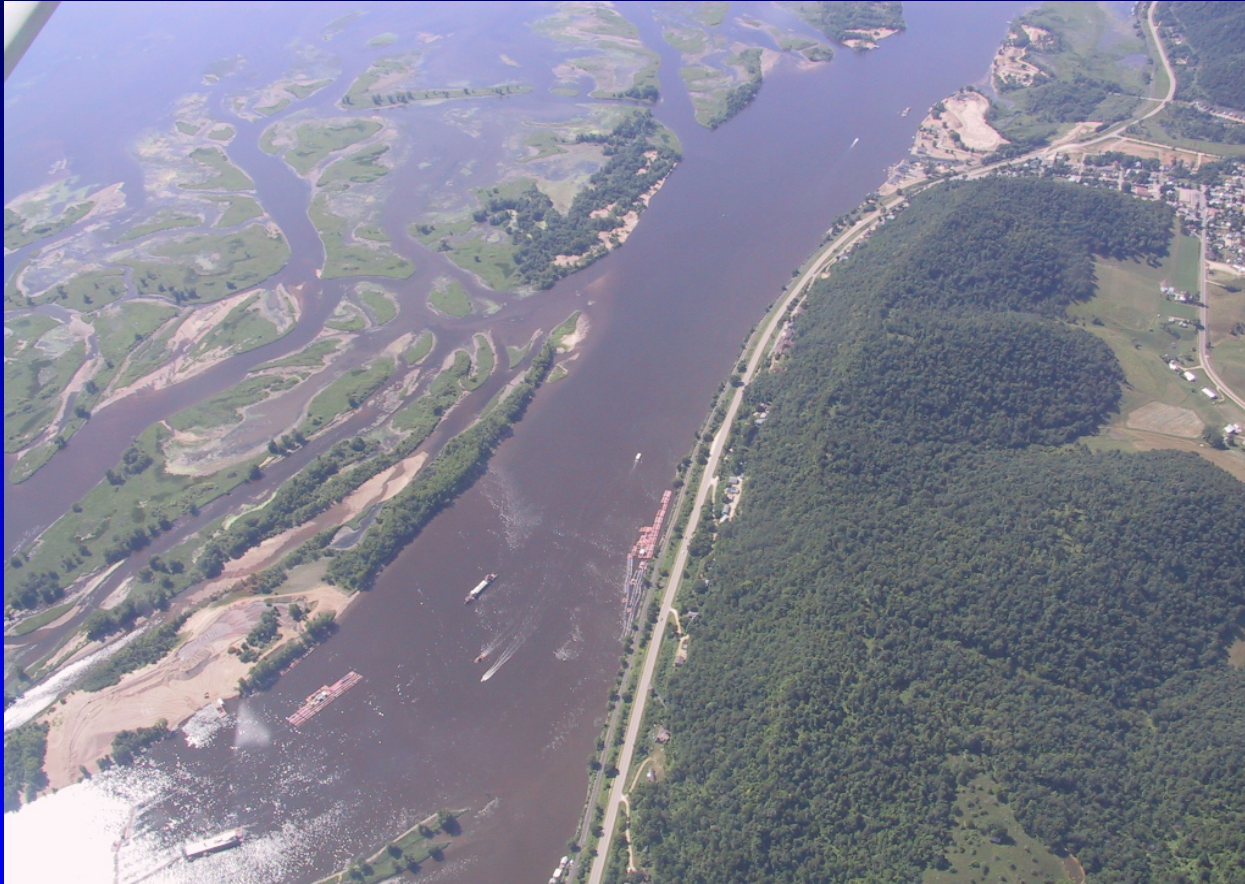
Upper Mississippi River Navigation Structures, Pool 8 Wing Dams

Pool 8 Wing Dams Conclusions

- 1. Pool drawdown (1.5 ft) during Summers of 2001 and 2002 to expose mud flats, promote seed germination, and benefit fish and wildlife.**
- 2. Wing Dam submergence and floodplain conveyance decreased.**
- 3. Flow patterns around structures was altered.**
- 4. Resulted in sediment mobilization and scour of the navigation channel.**
- 5. ISSDOT results were compared to (a) District Sediment Budget, and (b) analytical functions.**
- 6. ISSDOT and analytical functions yielded 800 tons/day. Sediment Budget yielded 550 tons/day (uncertainty exists about suspended load).**
- 7. River managers can more effectively plan their dredging with ISSDOT.**

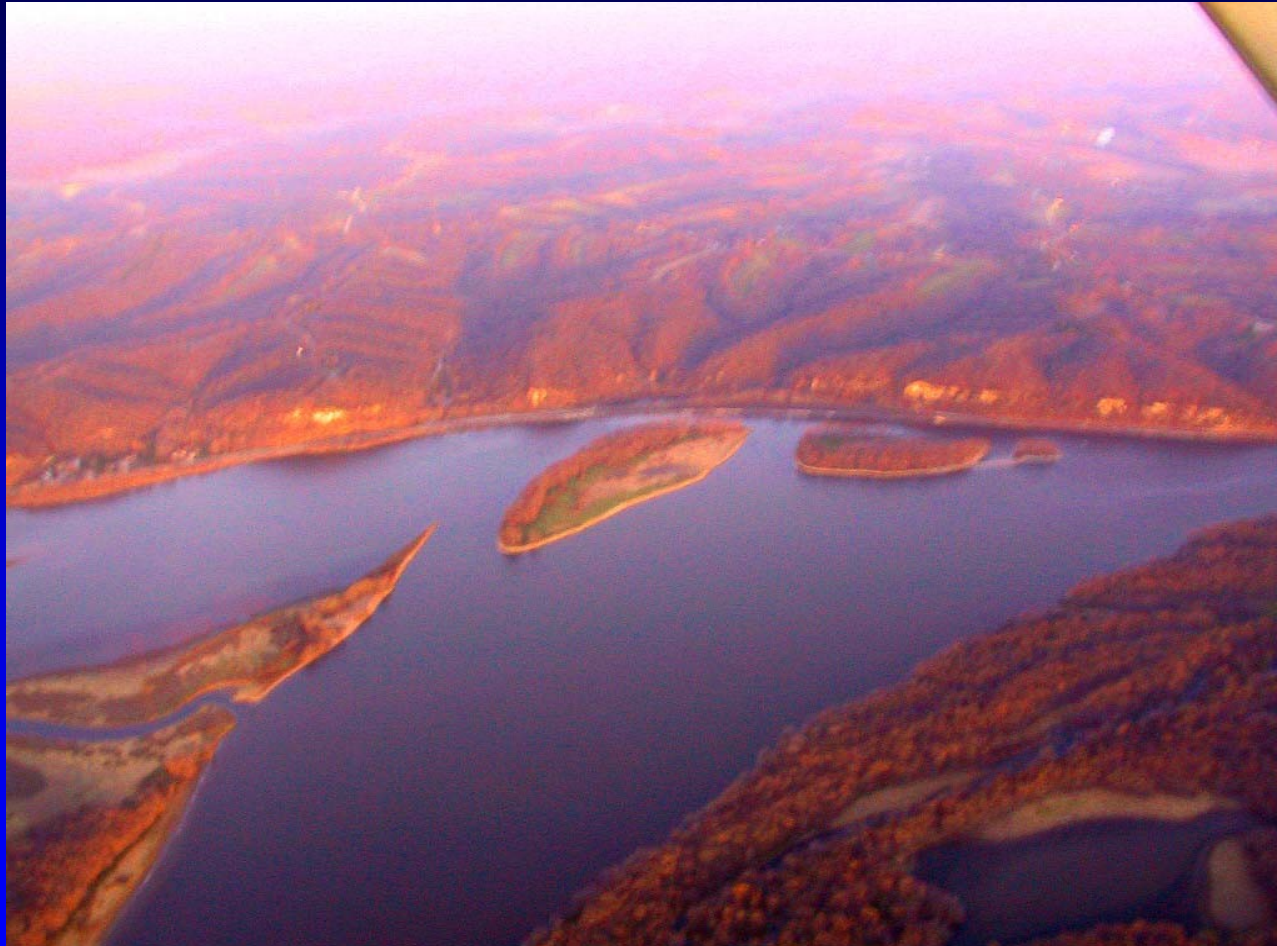
Upper Mississippi River Navigation Structures, Pool 13 Closure Dams Conclusions

1. **3 Closure Dams were constructed during Spring 2001 (submerged weirs to allow flow into backwater areas but at reduced rate), thus increasing flow in Main Channel.**
2. **Need to determine by ISSDOT if channel dredging would be reduced, and whether backwaters would fill with sediment.**
3. **For Main Channel, all regions had same scour first then redeposition trend. Lower region redeposition was not as much as other regions, thus showed a slight scour measurable difference (few tenths of a ft) between November 2001 and July 2004. Redeposition here may resume in future years. Dredging may not be reduced.**
4. **For Backwaters, all measurements show a net deposition trend, up to about 1.0 ft, for this study period.**

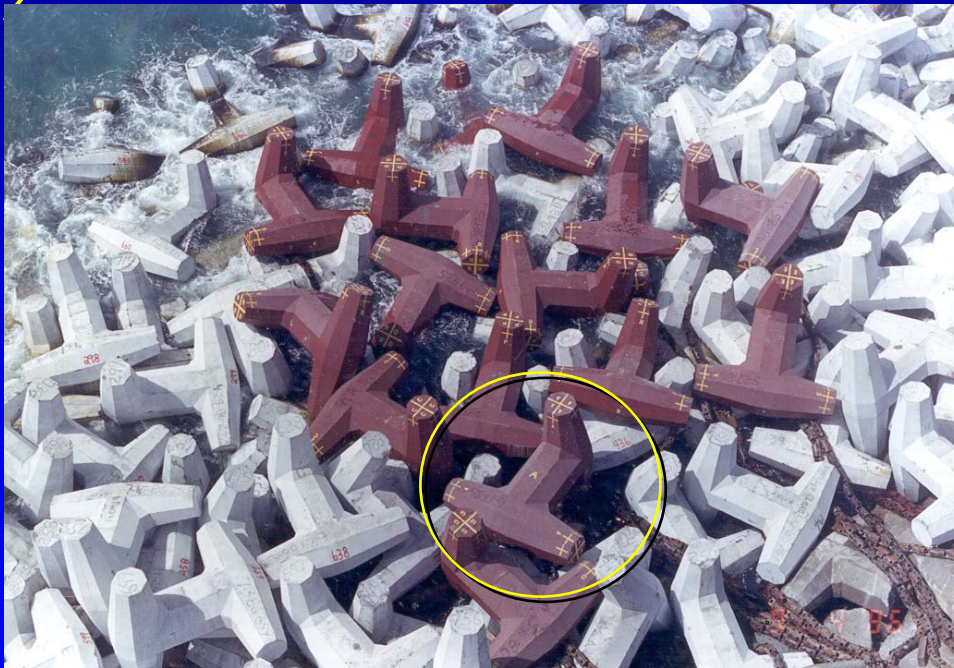
Crescent City Dolos Movement

Cumulative Movements by Aerial Survey

42 ton fiber reinforced dolosse
No recent movement to note
50 total broken

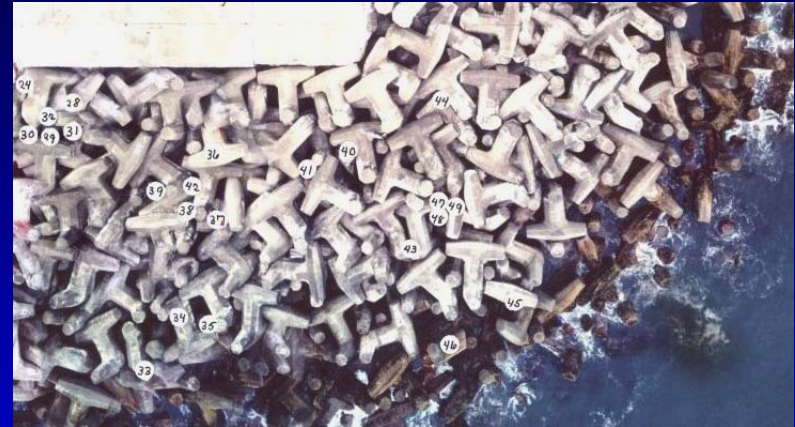
Dolos Strength and Breakage

14/760 cast in 1986

36/246 cast in 1974

No new breaks since 1993

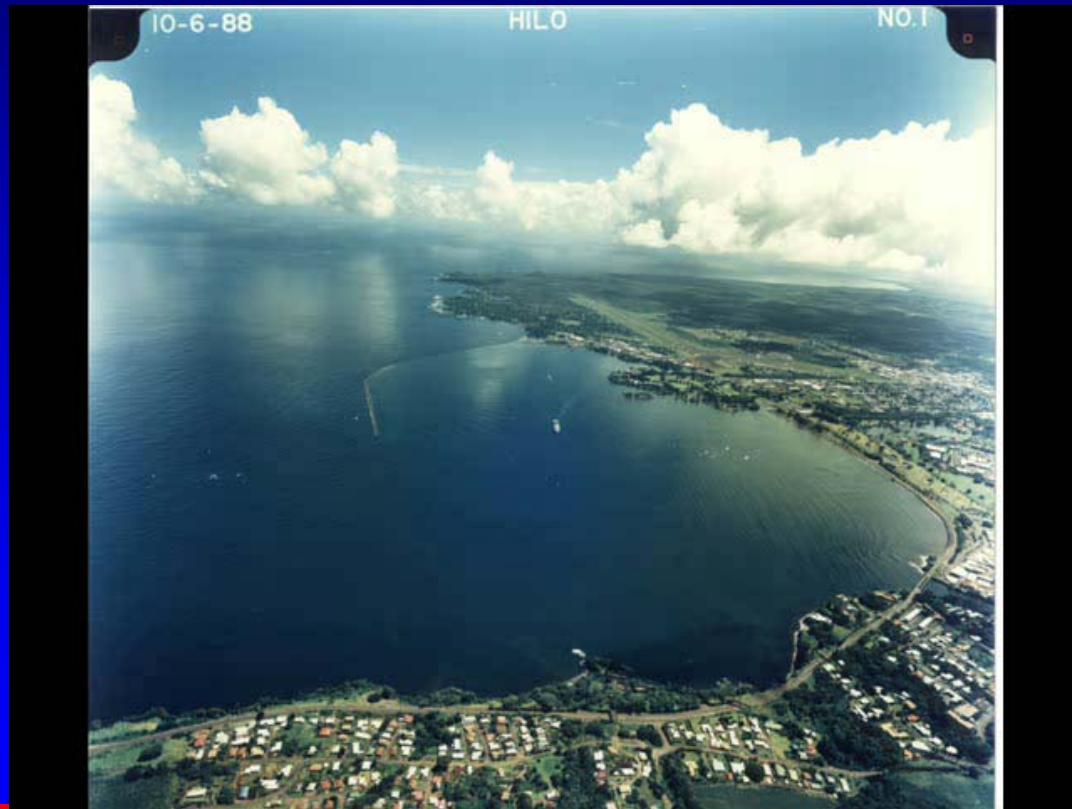
Hilo, Hawaii

Lidar Terrestrial and Multi-beam Sonar Bathymetry Surveys

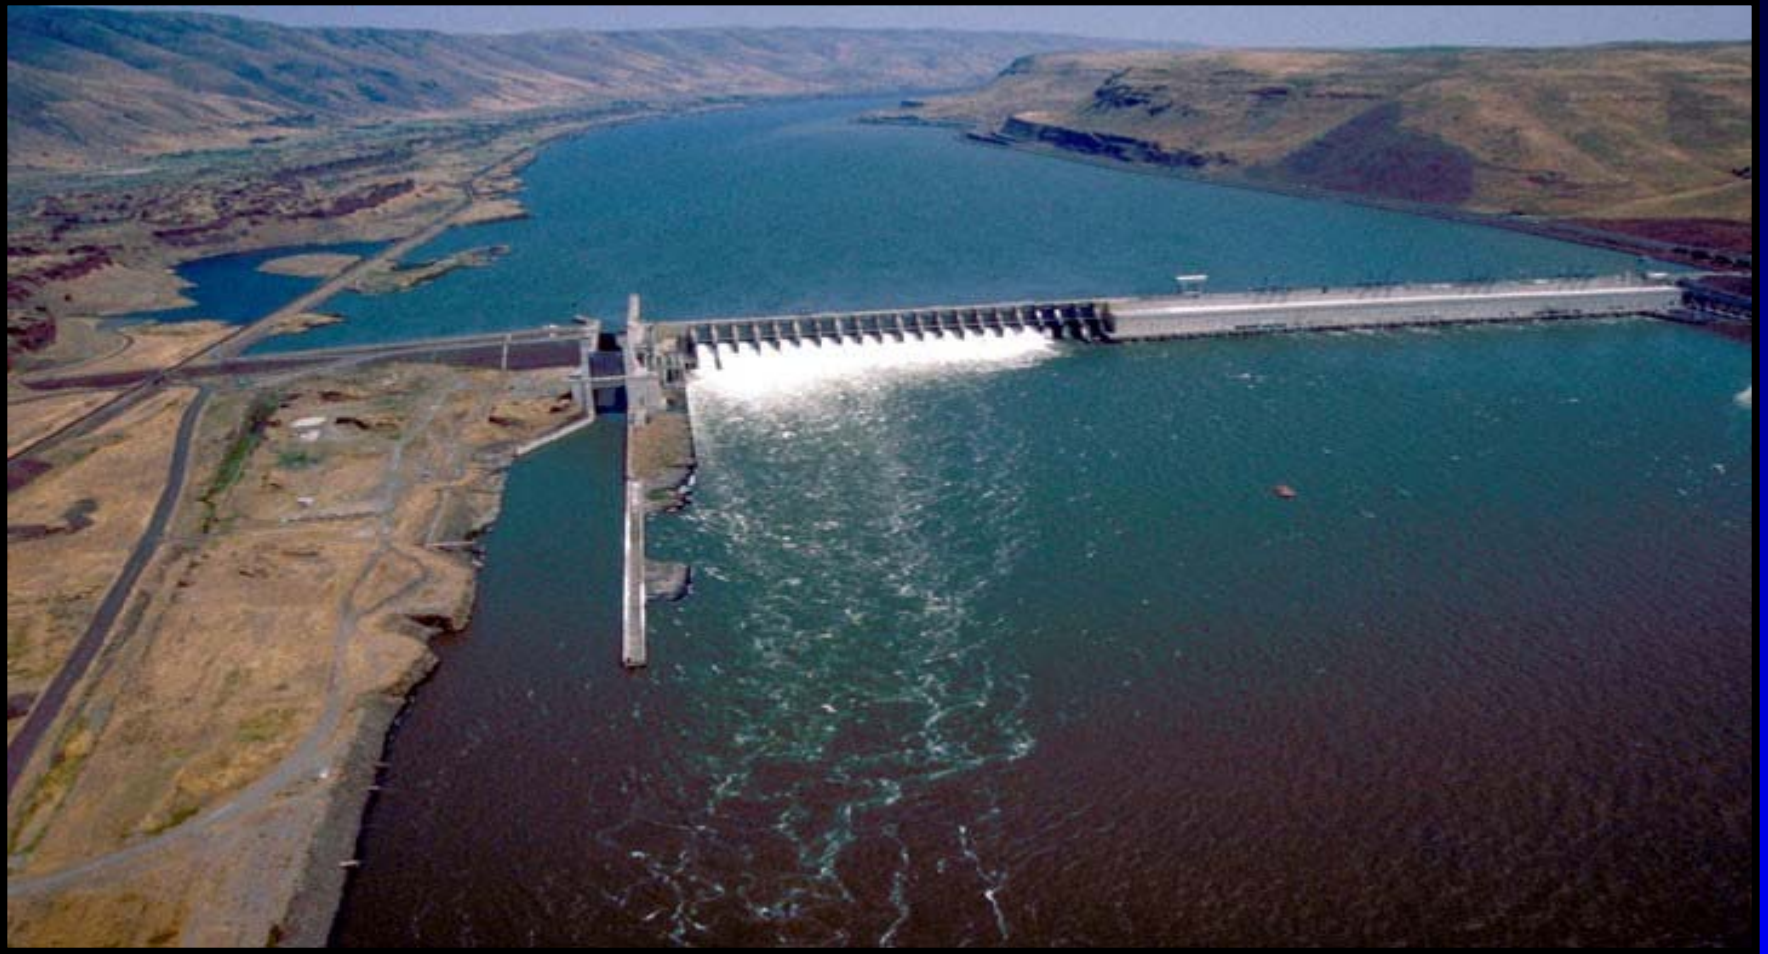
John Day Lock and Dam, Columbia River

Addition of (a) Spillway Flow Deflectors, and (b) Spill Pattern Generators, and (c) Changed Operations to improve fish passage through the tailrace environment and water quality, have adversely impacted the Dam's ability to safely meet it's navigation mission under certain river conditions.

Columbia River Towing Association (CRTA) has reported several instances of unsafe navigation conditions. Navigation conditions have been negatively impacted due to these modifications. System modifications should be investigated to eliminate unsafe navigation situation existing here and at 7 other similar dams located on the Lower Columbia and Lower Snake Rivers.

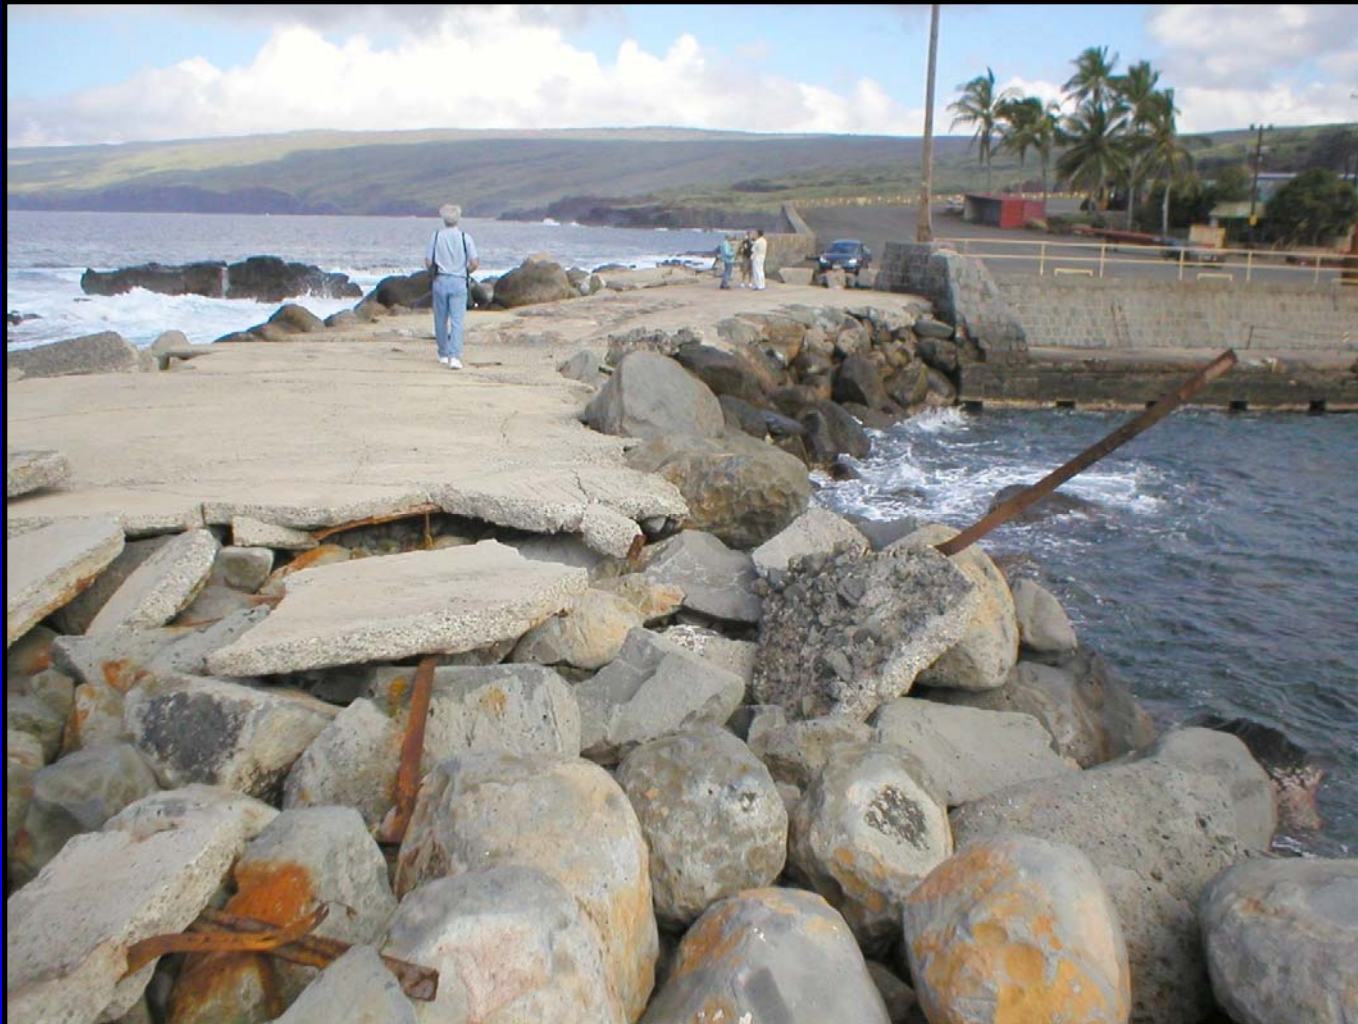
Kaumalapau Harbor Breakwater

Harbor, constructed in 1922, is the only deepwater port on the island, and services the hotel tourist and farming industry, and import of food and commercial goods. The breakwater has severely deteriorated over the years.

Because of non-availability of large quarry stone, it is necessary to use manufactured armor units at this site (water depths 70 ft; wave heights 30 ft). 35-ton CORE-Loc armor units (largest ever manufactured) will be installed (790 units). Will be placed over existing broken dolos armor units. It is significantly important to understand the design, stability, construction, and performance of these units.

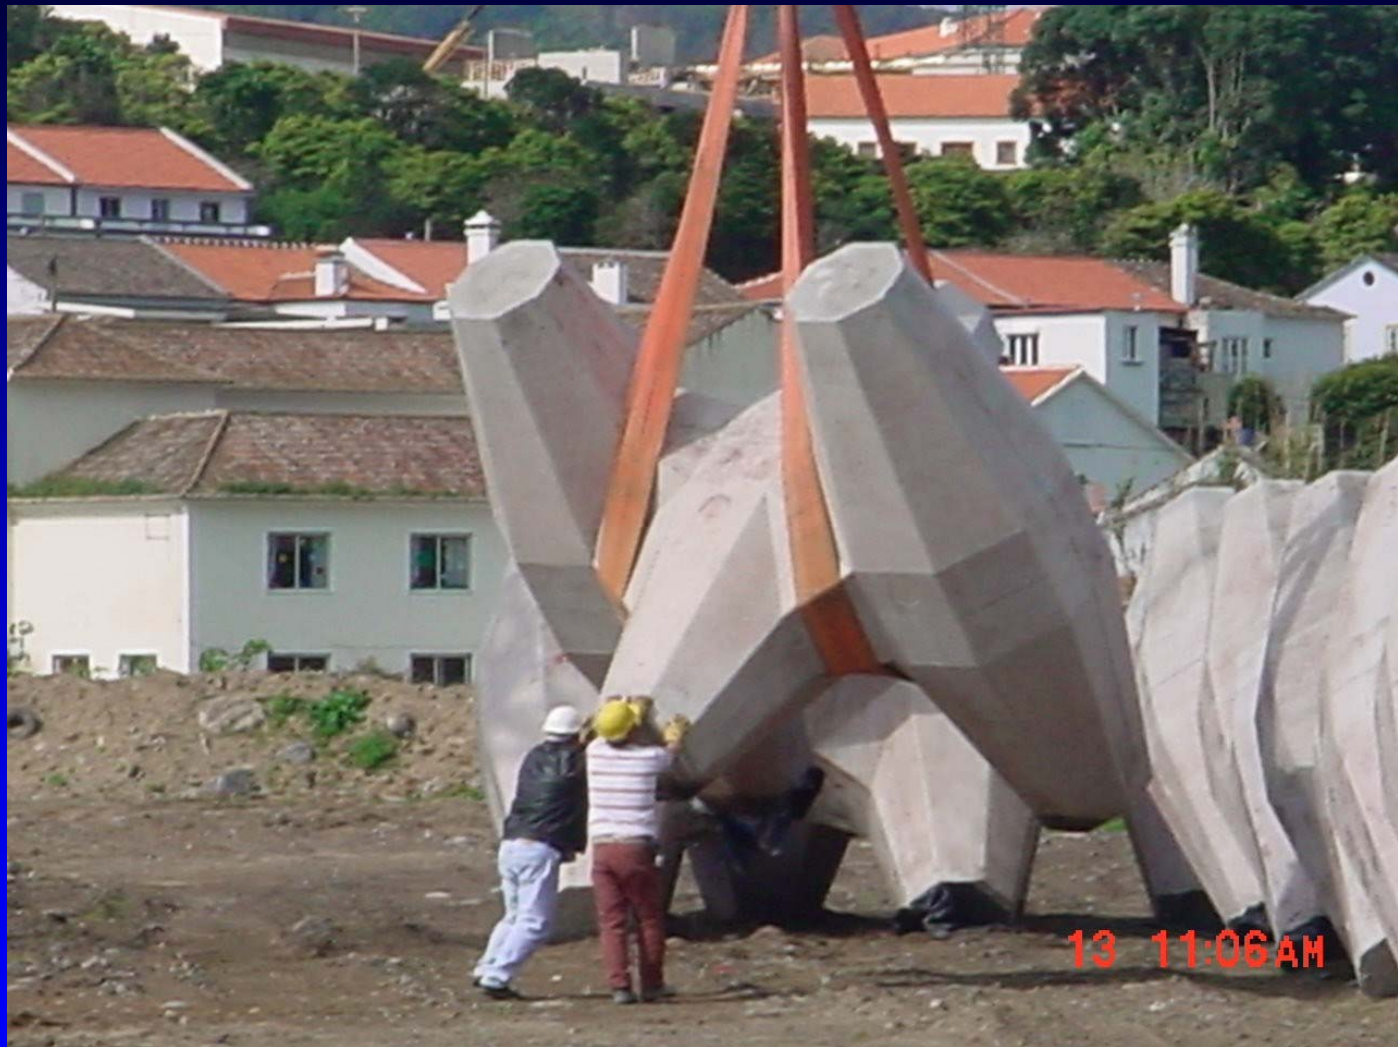
Old Shape 35-Ton CORE-Loc, Azores

- 1. Contractor fabricated 10 forms based on previous Azores configuration.**
- 2. Storm damage in Azores resulted in a few cracks in some CORE-Locs.**
- 3. CORE-Loc redesign was recommended.**
- 4. 3 new CORE-Loc test forms were fabricated.**
- 5. Difficulty with concrete mix design not meeting both temperature and temperature differential specifications.**
- 6. Further analysis indicated Azores problems may have been with placement.**
- 7. Hence, previous Azores form configuration could possibly have been o.k.**
- 8. Bottom Line: Prototype units will be formed in 2006 instead of 2005.**

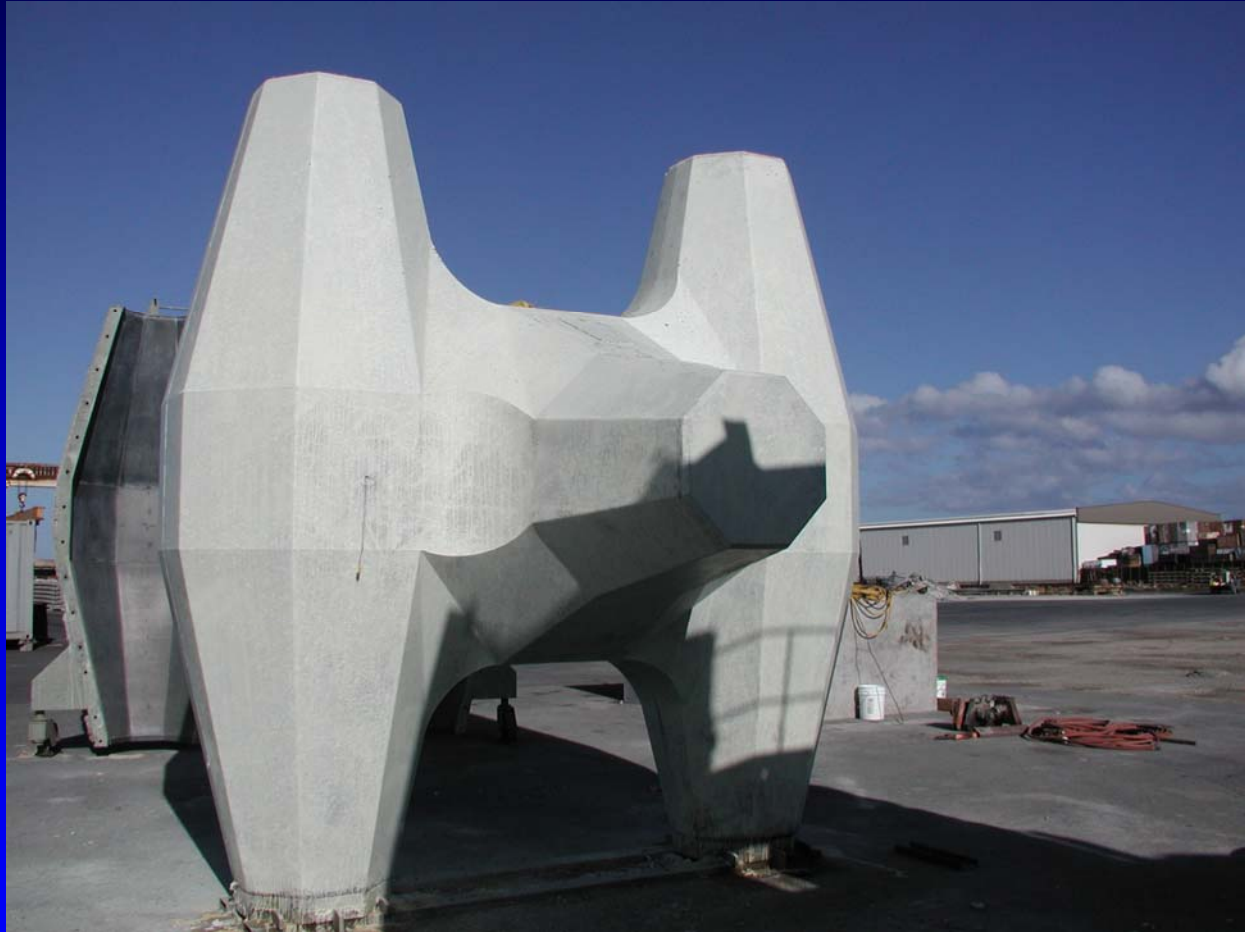
35-Ton CORE-Loc for Rehabilitating Kaumalapau Harbor Breakwater

**790 CORE-Loc
units will be cast**

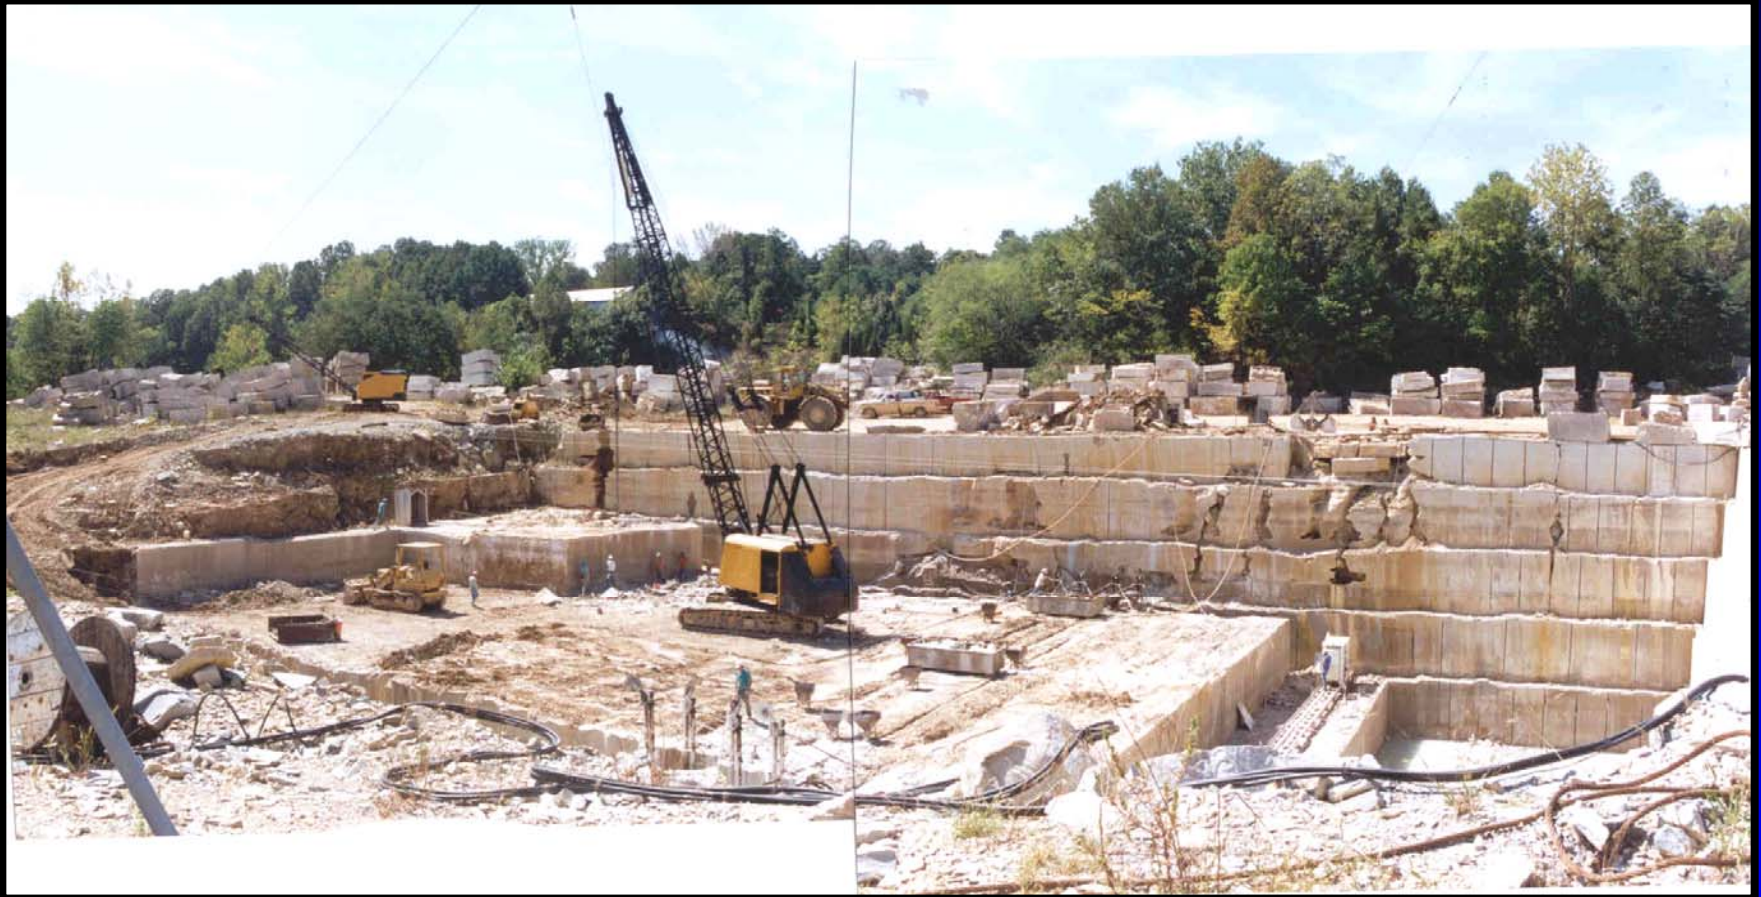
Wire-Saw Cut Quarry Operation

Reed Quarry, Bloomington, IN

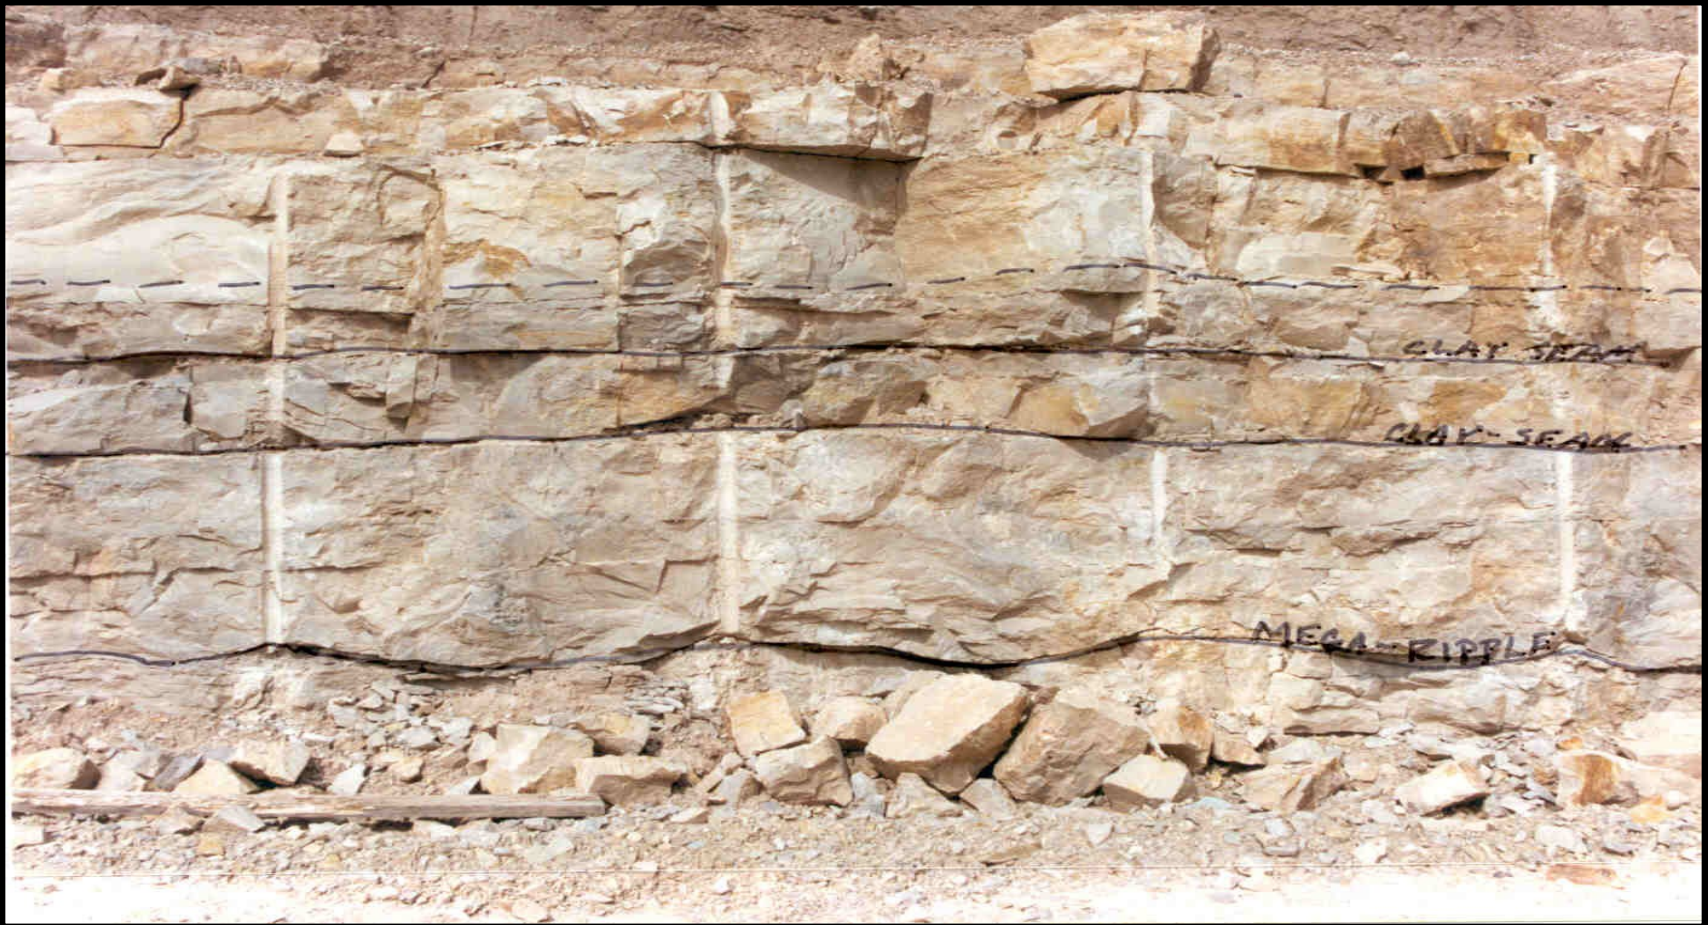
Drilled and Blasted Quarry Operation

Valders Quarry, Valders, WI

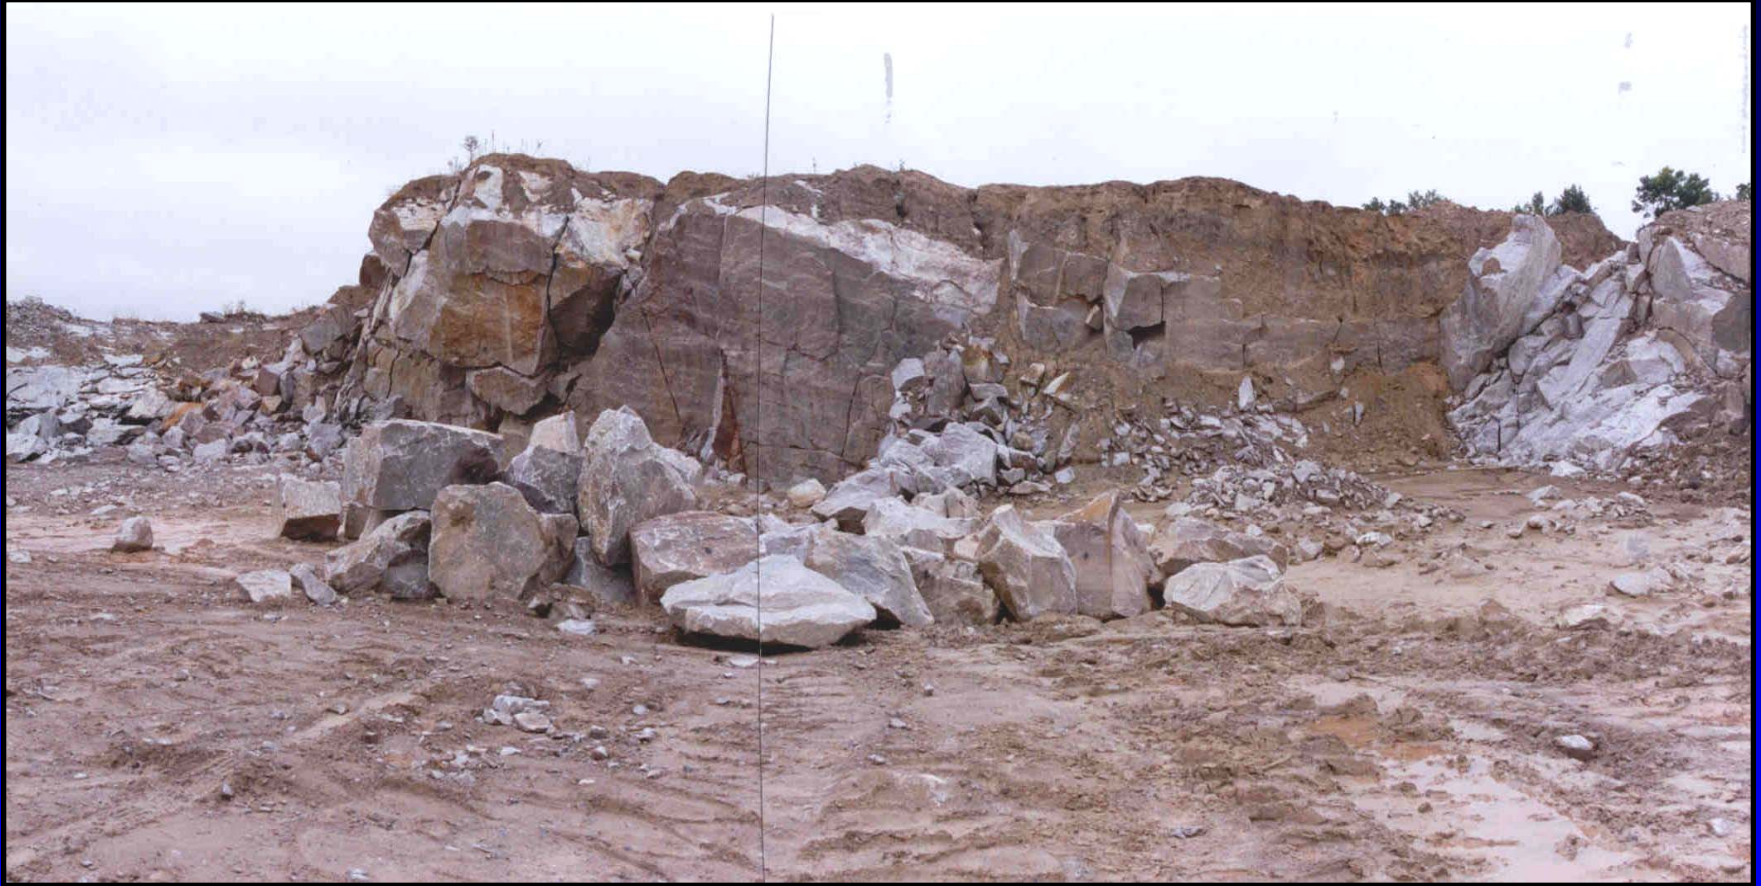
Drilled and Blasted Quarry Operation

Dempsey Quarry, Waterloo, WI

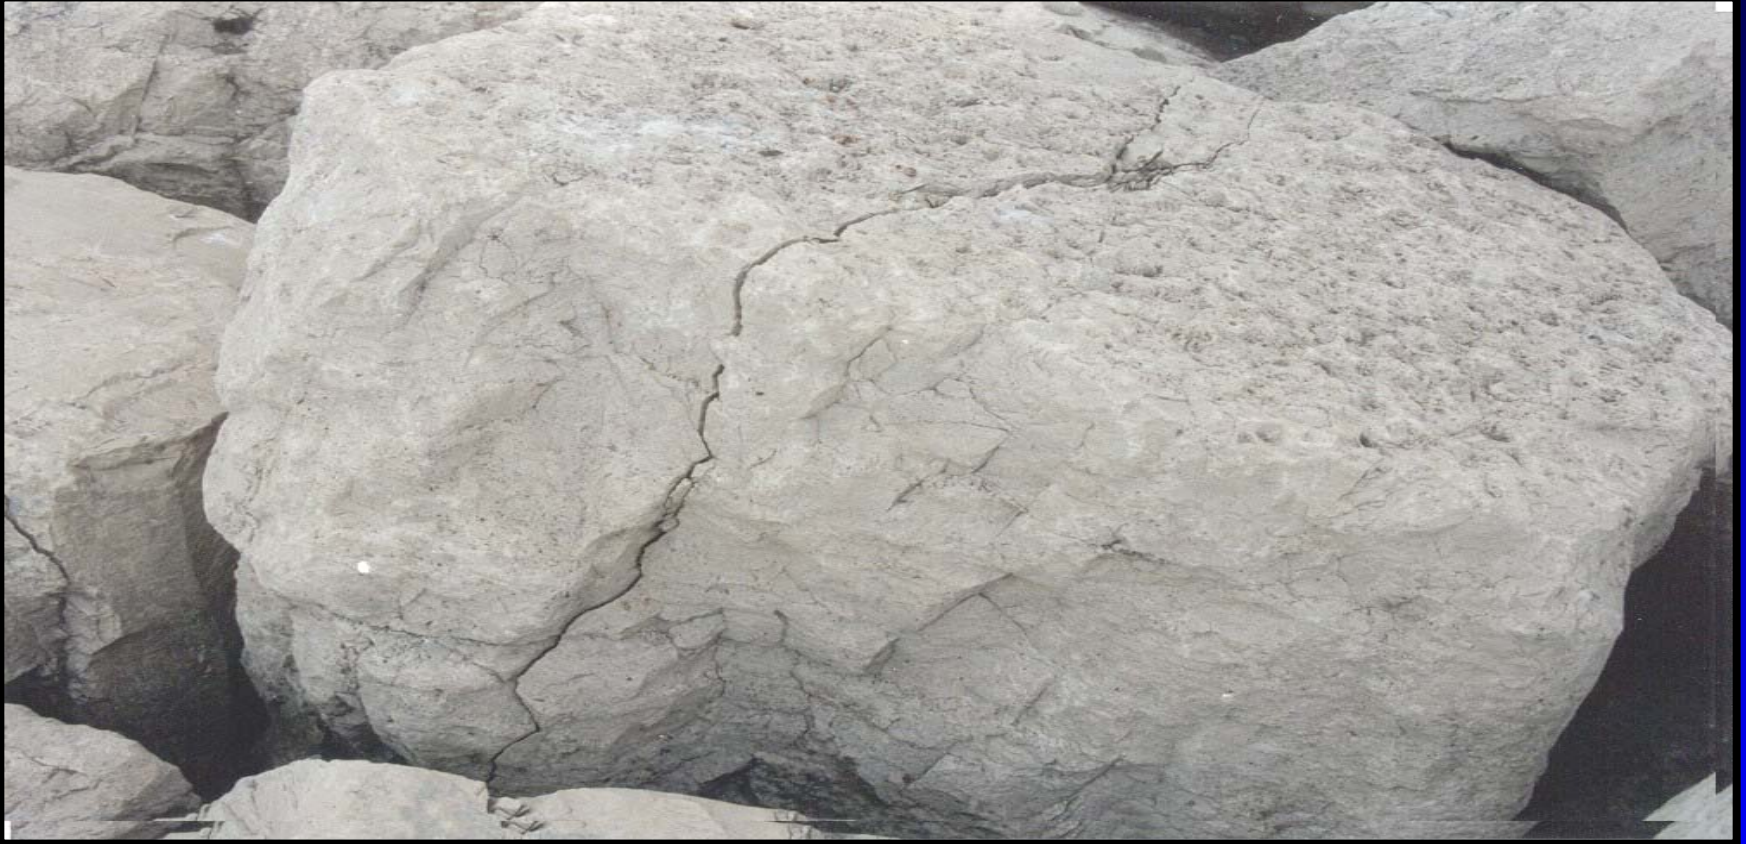
High-Energy Blasted Dolomite McCook Quarry, McCook, IL
